CHANGES IN RIPARIAN VEGETATION IN THE SOUTHWESTERN UNITED STATES: Historical Changes Along the Mojave River, California

USGS GROUND WATER RESOURCES PROGRAM

U.S. GEOLOGICAL SURVEY OPEN-FILE REPORT OF 01-245, 2001

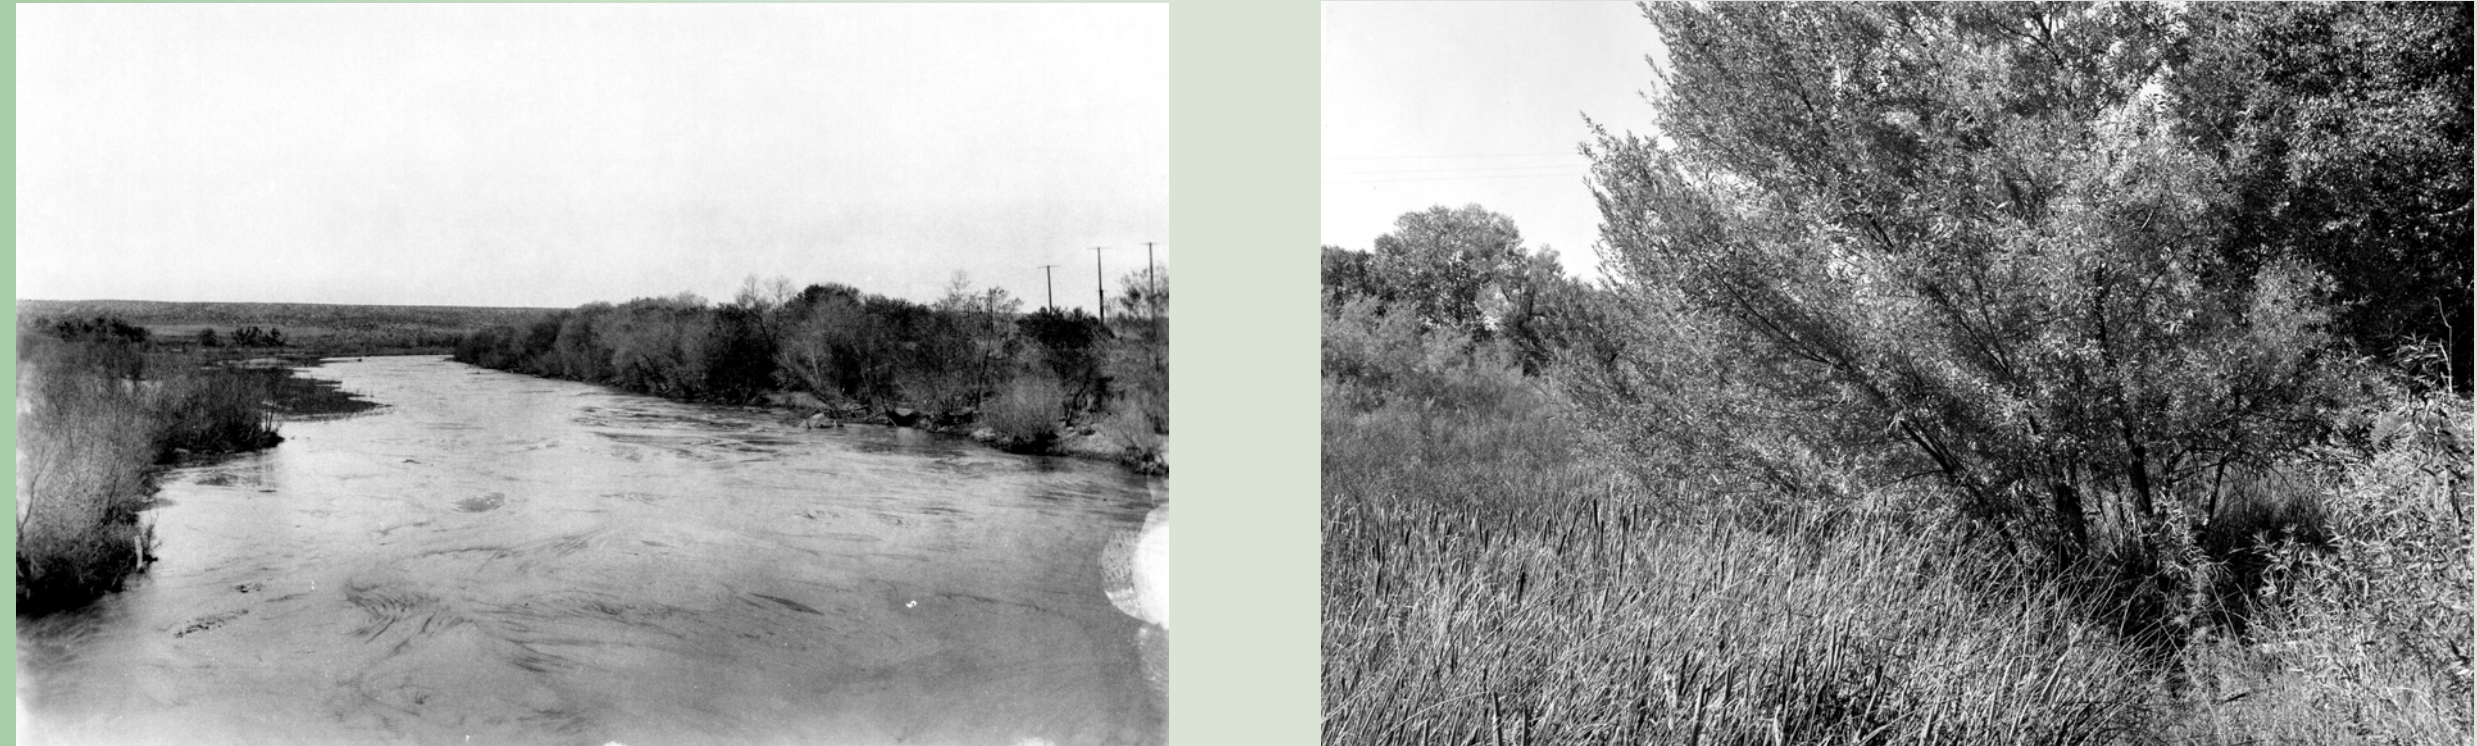
(1917). Thompson took this downstream view of the Mojave River from the deck of a highway bridge. Most of the trees appear to be Goodding willows, leafless in the winter season, and cottonwoods appear at several places, particularly on river right (right side). The channel is unconfined by bedrock here and is very wide, possibly in response to recent floods (David Thompson 443, USGS Photo Library).

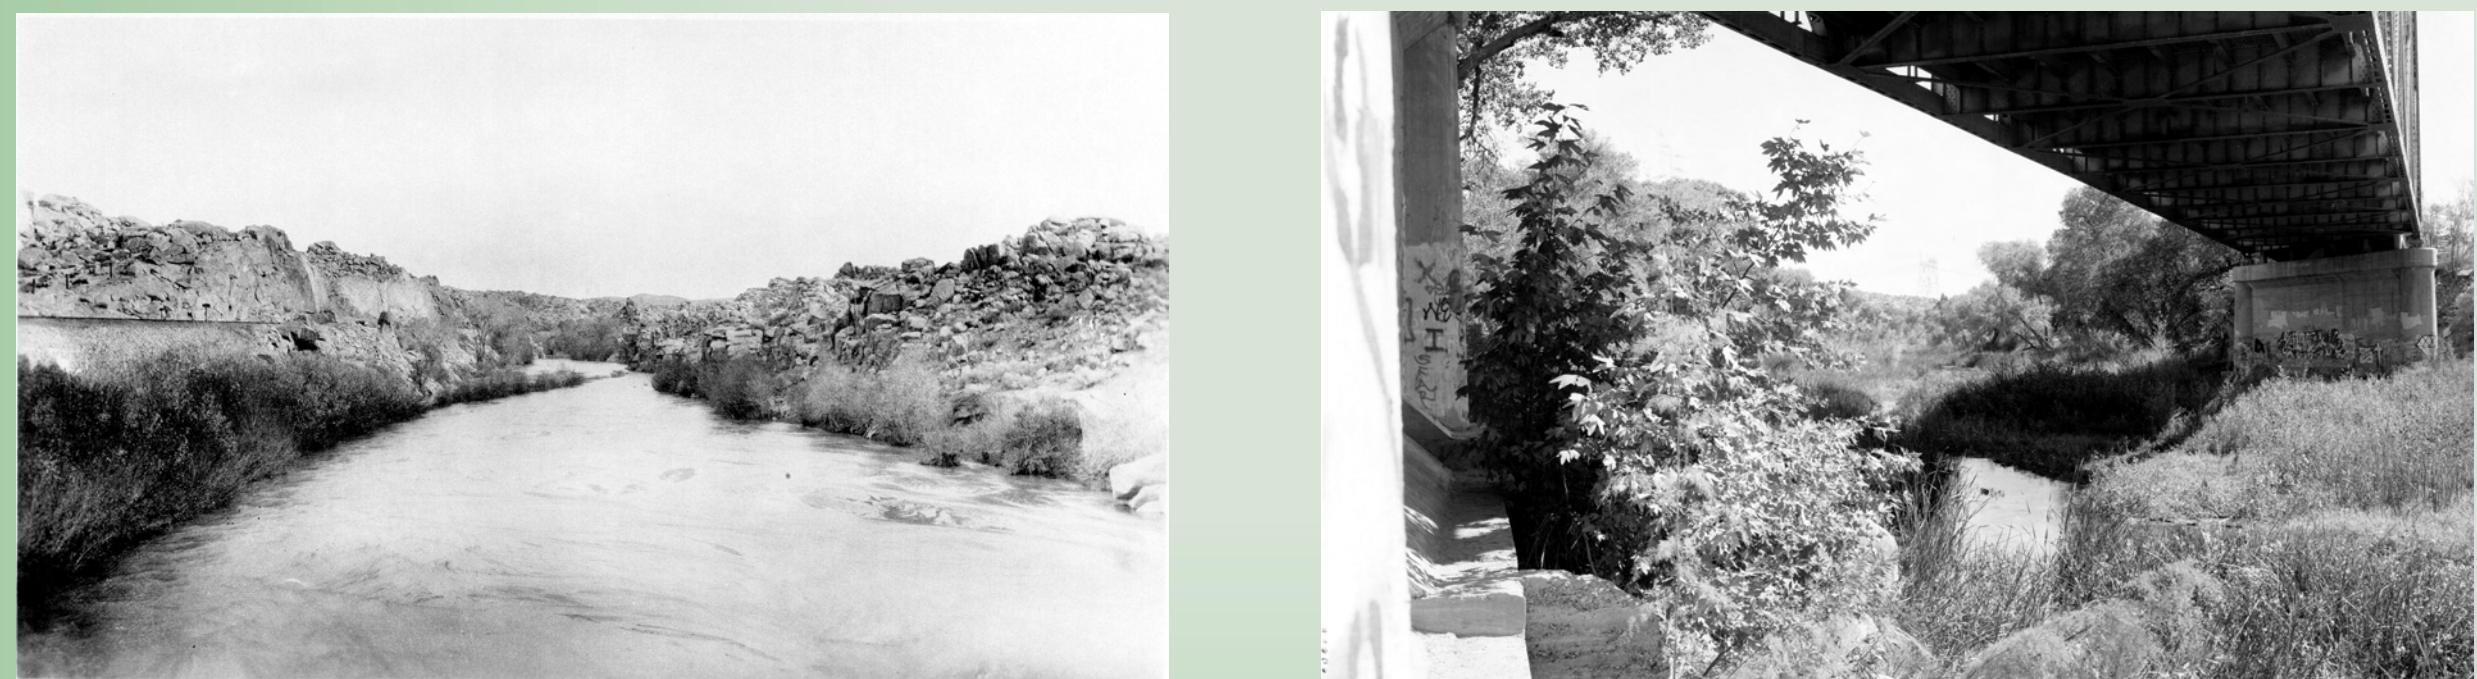
(1917). In this upstream view from the same bridge, the main railroad between Salt Lake City and Los Angeles is at left. The shrubs along the channel appear to be mostly coyote willow and seep willow. What appear to be small cottonwood trees are in the middle distance (David Thompson 444, USGS Photo Library).

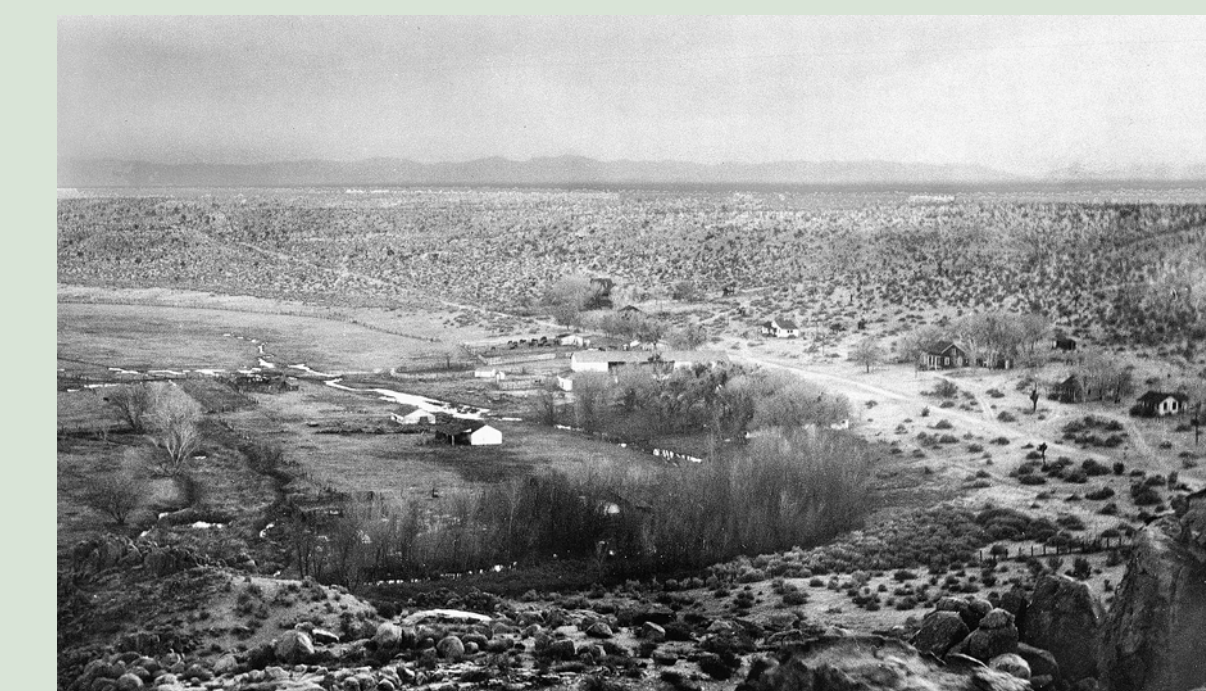
(1917). Thompson photographed this upstream view of the Mojave River at the Upper Narrows as part of a 360° panorama. The leafless trees indicate the season is winter. The band of trees nearest the photograph appear to be mostly Goodding willows, but scattered cottonwoods are also in the view (David Thompson 445, USGS Photo Library).

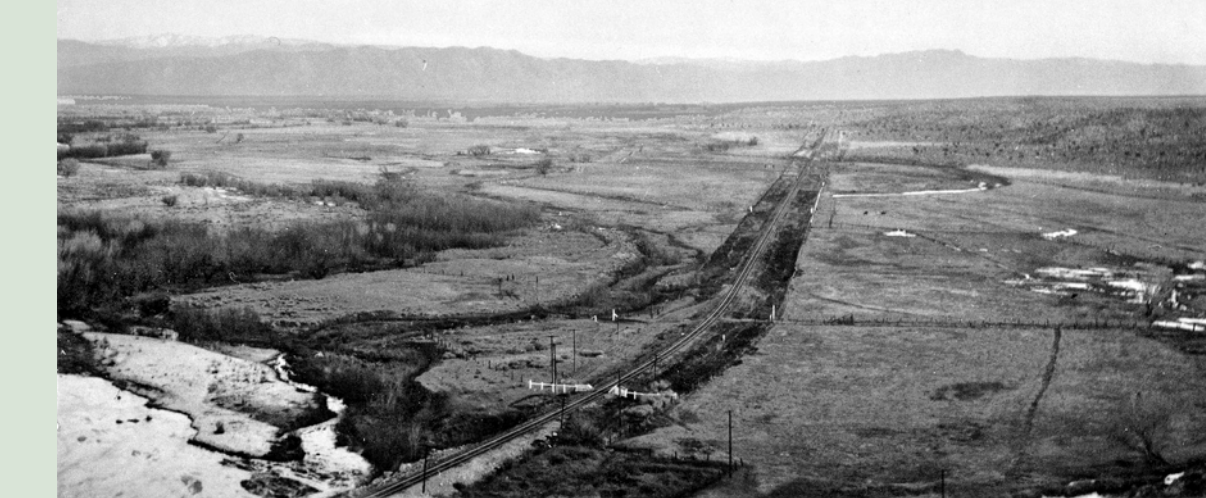
(1917). This view, a pan to the left from the previous view, shows the main railroad line from Los Angeles to Salt Lake City as it passes out of the Mojave Desert into Cajon Pass and the Los Angeles basin. This single-track line is built on a berm that forces most surface water moving down the Mojave River to the left (ess), although ground-water seepage appears in pools on the right. At left, the river floodplain has scattered Goodding willows. At right center, the railroad berm truncates a meander of the river, which now appears to be a disconnected slough with scattered trees along its banks (David Thompson 446, USGS Photo Library).

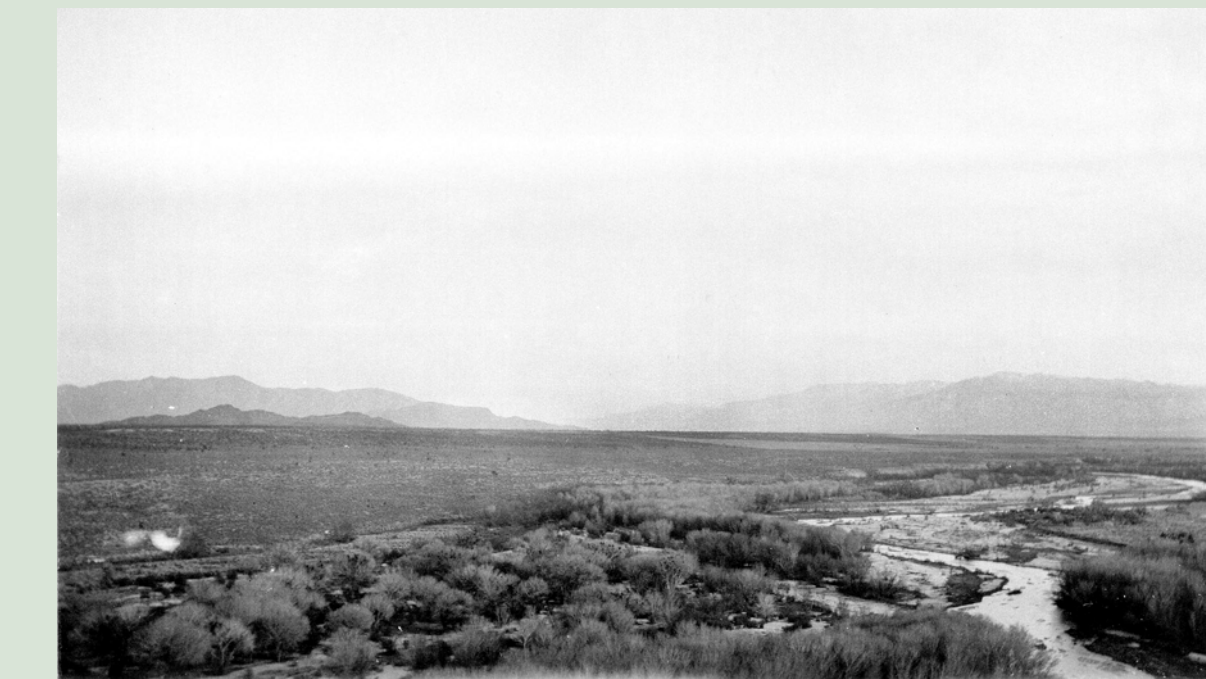
(1917). In this third view, a pan even further to the left from the two above, the trees appear to be mostly Goodding willow. A few cottonwoods appear in this view, particularly one at lower center, and some low shrubs along the channel appear to be coyote willows. The Mojave River is flowing towards the camera and has a wide, mostly denuded floodplain. Vegetation on this floodplain may be recovering from damages sustained in the 1916 flood, which was one of the largest on the Mojave River (David Thompson 447, USGS Photo Library).

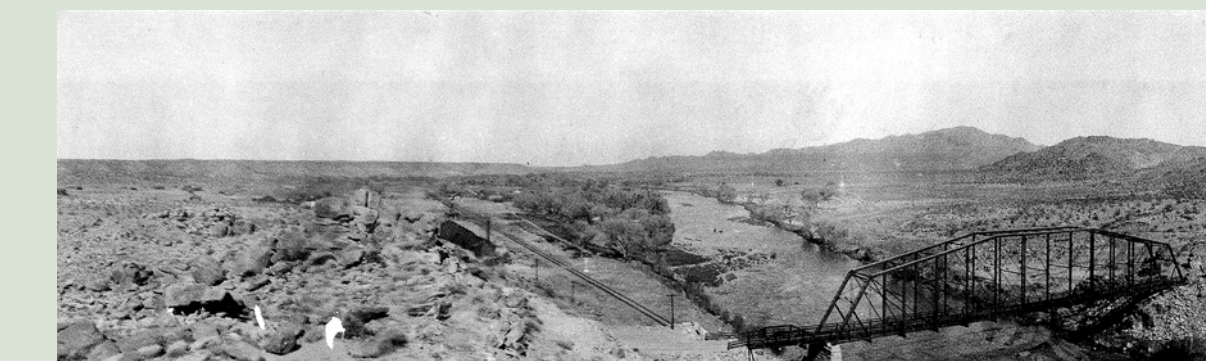
(1901). This downstream view towards Lower Narrows shows the former highway bridge across the Mojave River below the Narrows as well as the main railroad line leading towards Barstow. The trees in the middle distance and on river left are a mixture of cottonwoods and Goodding willows. The river channel is very wide, probably in response to 19th century floods including the 1891 event (M.R. Campbell 173, USGS Photo Library).

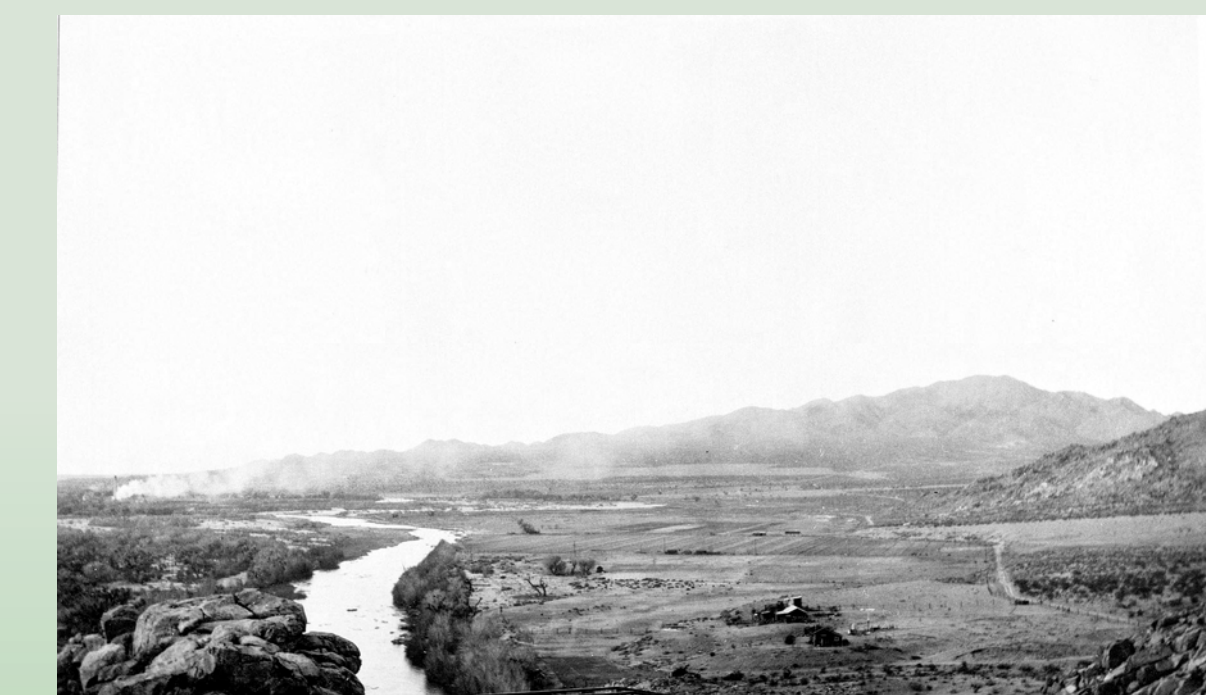
(1917). From a slightly different position than the 1901 view, above, Thompson photographed this downstream view along the Mojave River. A few ranches appear in the view, suggesting that grazing is a major land use in the floodplain. The river apparently is in flood. A fire is sending smoke from left to right across the background. Because of the architecture of their branches, the small, leafless trees along the river appear to be Goodding willows (David Thompson 450, USGS Photo Library).

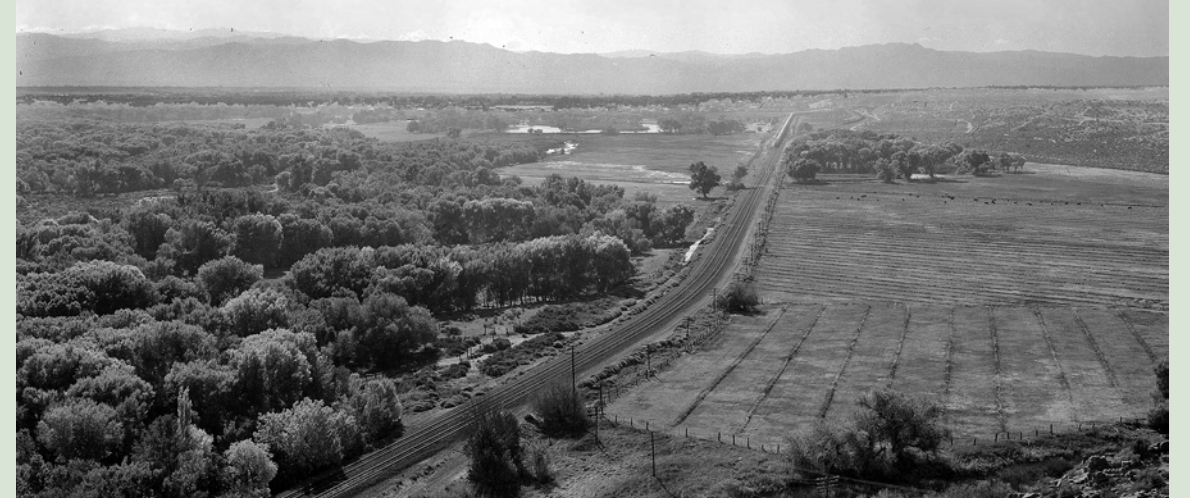
(October 24, 2000). Most of the land to the left (east) of the railroad is now in the Mojave Narrows Regional Park. Most of the trees visible are cottonwoods, although Goodding willows are still present. The fields in the right foreground are alfalfa, and cattle are grazing in the middle distance in front of a line of cottonwoods growing along the slough (Dominic Oldershaw, Stake 2110j).

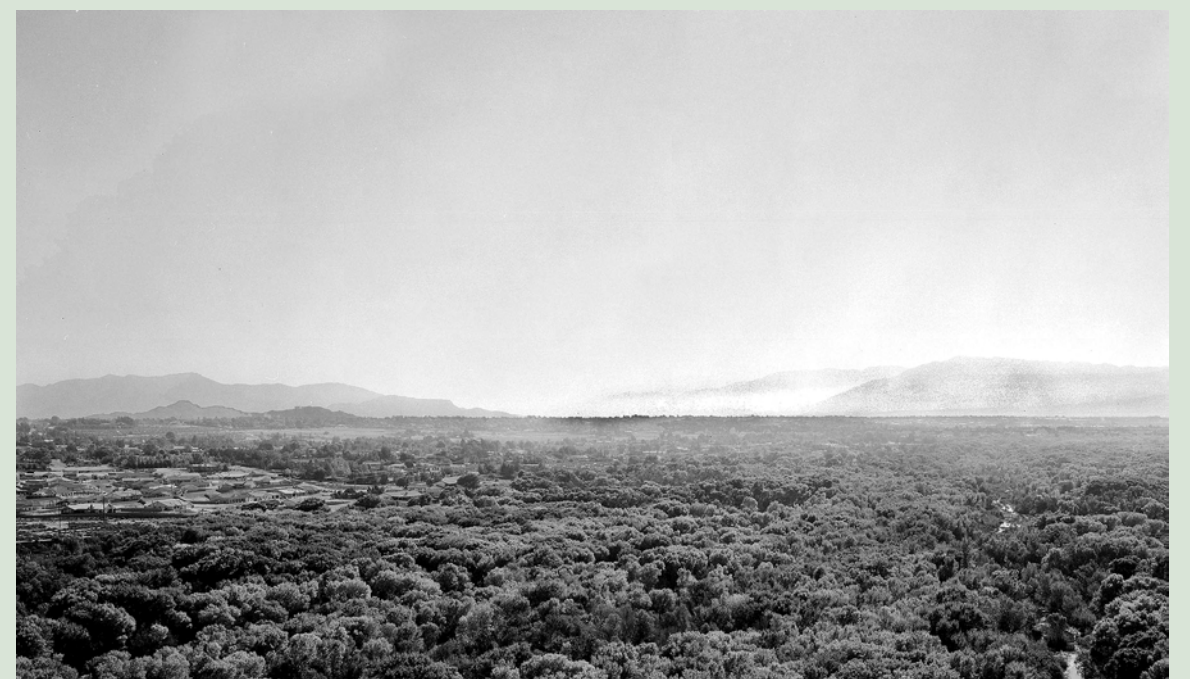
(October 24, 2000). Most of the riparian forest shown in this view is in the Mojave Narrows Regional Park. The channel of the Mojave River has decreased to a mere fraction of its former width, in part because of regulation by dams upstream and the influence of the riparian vegetation. The trees present are mostly cottonwoods, but very large Goodding willows and other species are also present. The white haze in the background is smog over Cajon Pass (Dominic Oldershaw, Stake 2110e).

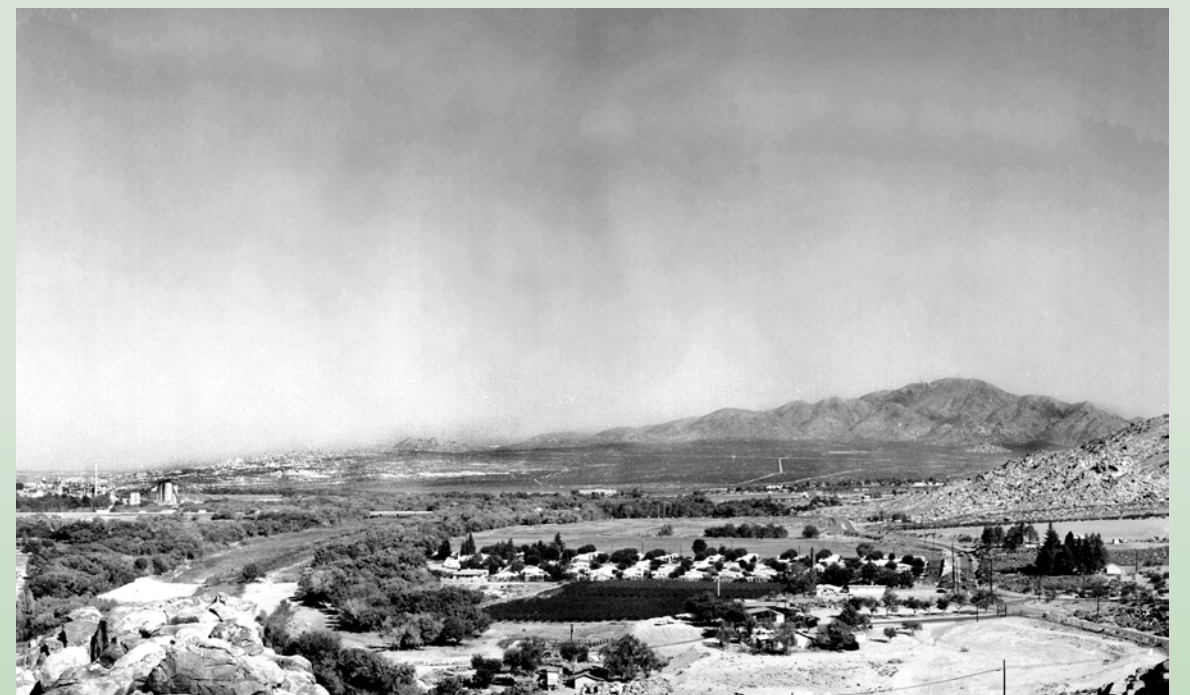
(October 24, 2000). Development associated with downtown Victorville has changed the land use away from ranching, and no grazing occurs here. The perennial flow creates ideal conditions for the growth of riparian vegetation. The width of the channel has decreased by about two thirds, and the floodplain background has been replaced by tamarisk, native willows, and herbaceous species. Cottonwood trees now dominate the river on both sides (Dominic Oldershaw, Stake 2110c).

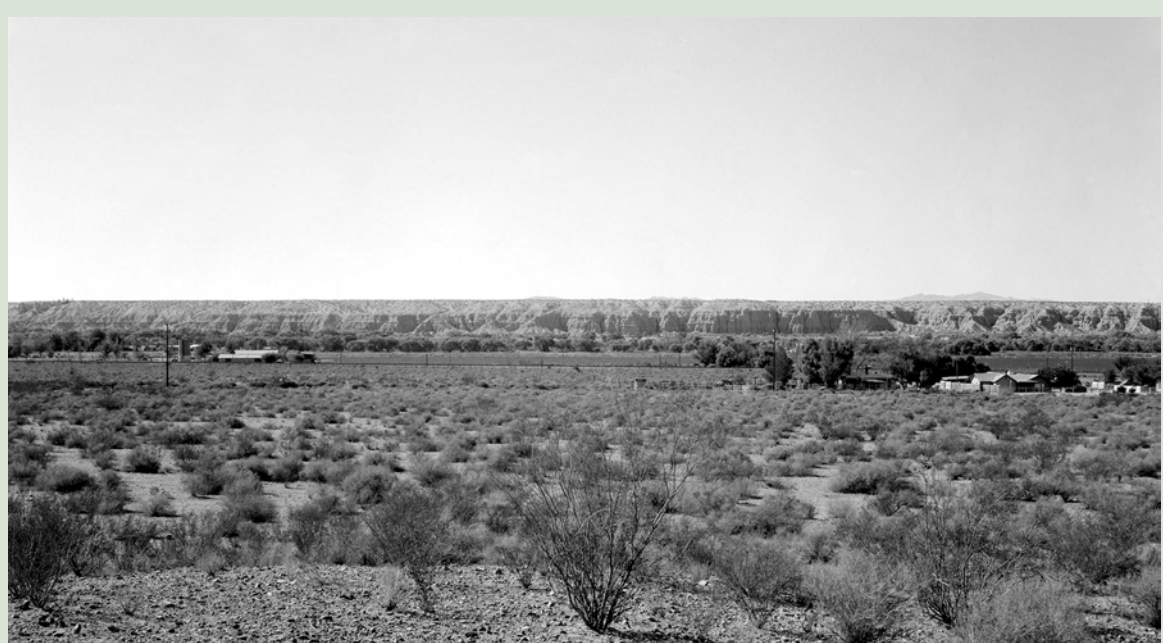
(October 24, 2000). The trees along the river have increased in size and number despite ground-water pumping in the vicinity. Cottonwood is now the most obvious species from the skyline. The number of creosote bushes and other small shrubs in the foreground has greatly increased (Dominic Oldershaw, Stake 2114a).

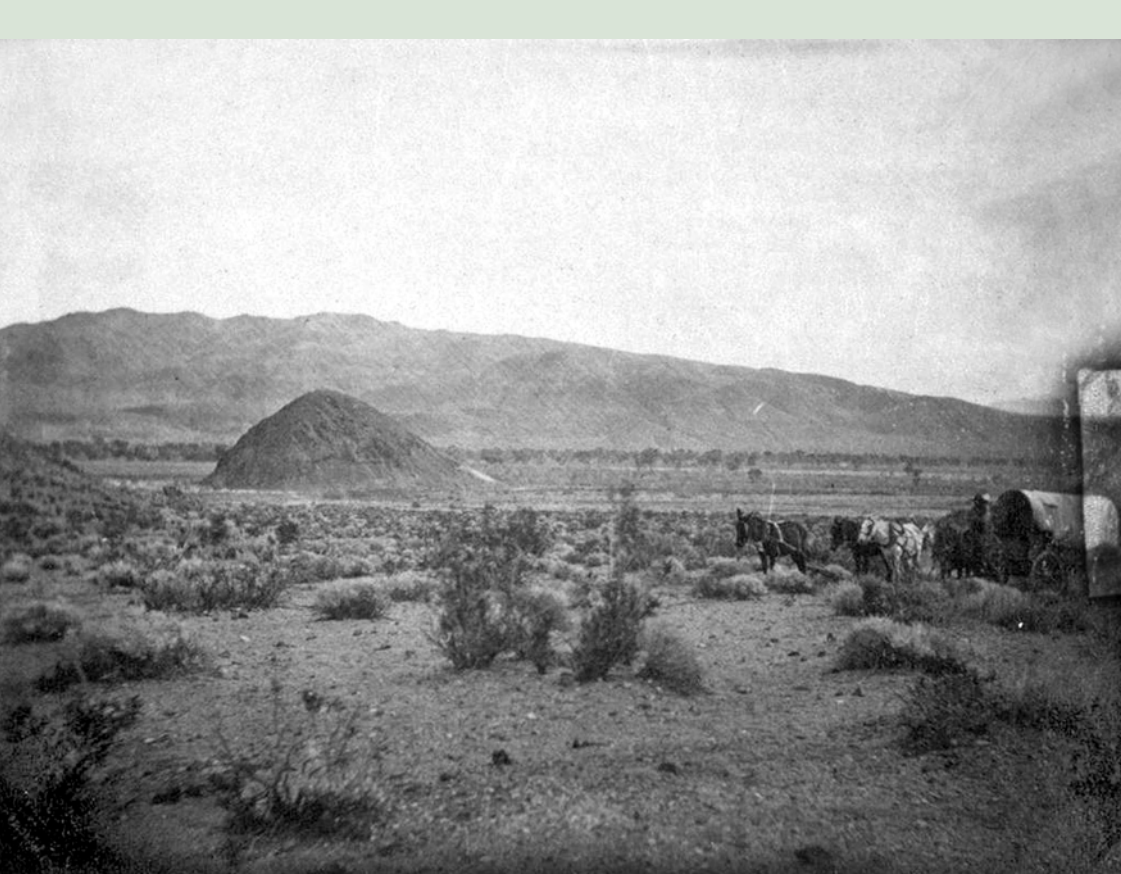
(1863). The California Geological Survey party of 1863, en route from San Bernardino to the Colorado River, paused at the future site of Barstow along the Mojave Road. The party called the low hill at left center 'Sugarloaf.' The foreground plants are creosote bush and cattle spinach (*Atriplex polycarpa*). In the distance, trees line the channel of the Mojave River. Their stature suggests they likely are mostly Goodding willow, although a positive identification is impossible (Richard D'Heureuse 1905.16894NA, courtesy of the Bancroft Library).

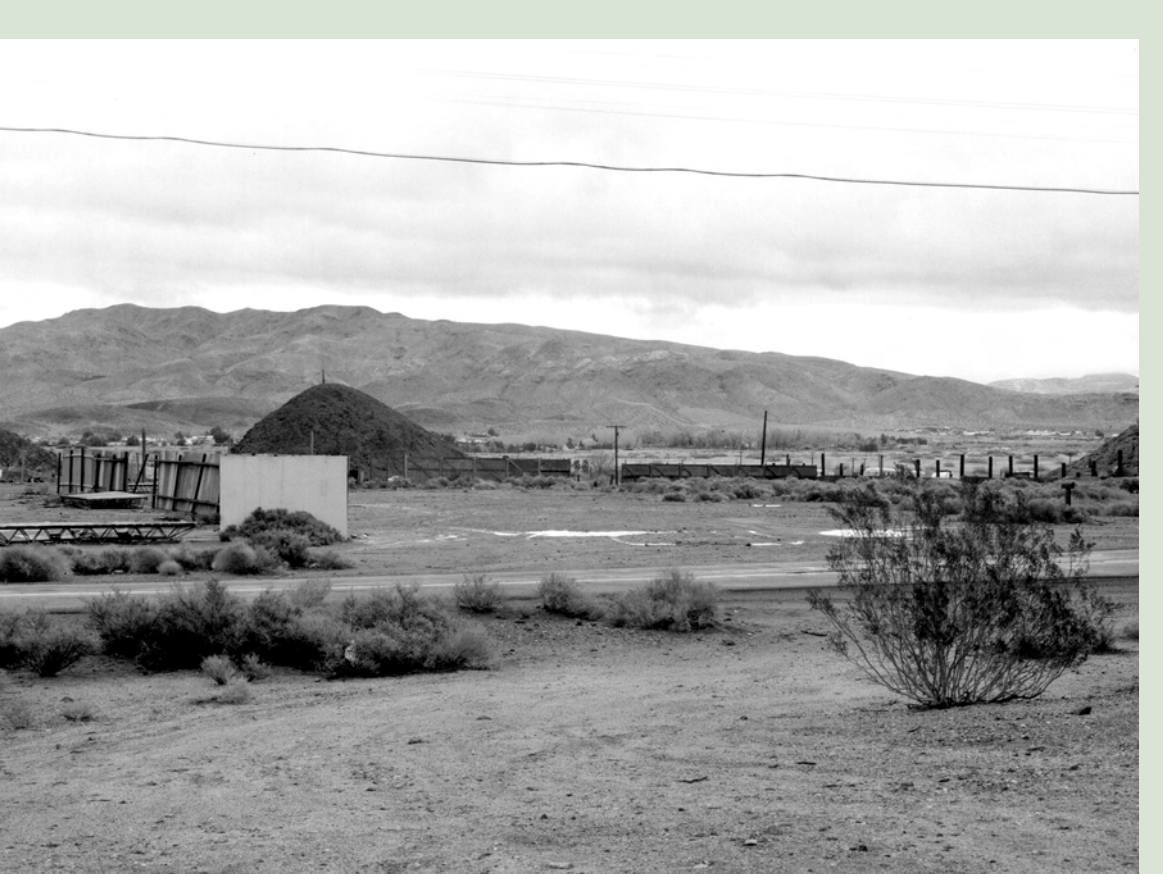
(February 26, 2001). The camera station is on the edge of a railroad cut (behind the view) east of downtown Barstow, and vegetation and topography in the foreground and midground have been disturbed. Because of ground-water pumping, almost the entire native riparian system in this area has been obliterated with the exception of mesquite hummocks on the north side of the river. The trees in the distance are a mixture of cottonwoods and non-native species, planted within a subdivision and irrigated (Dominic Oldershaw, Stake 2225).

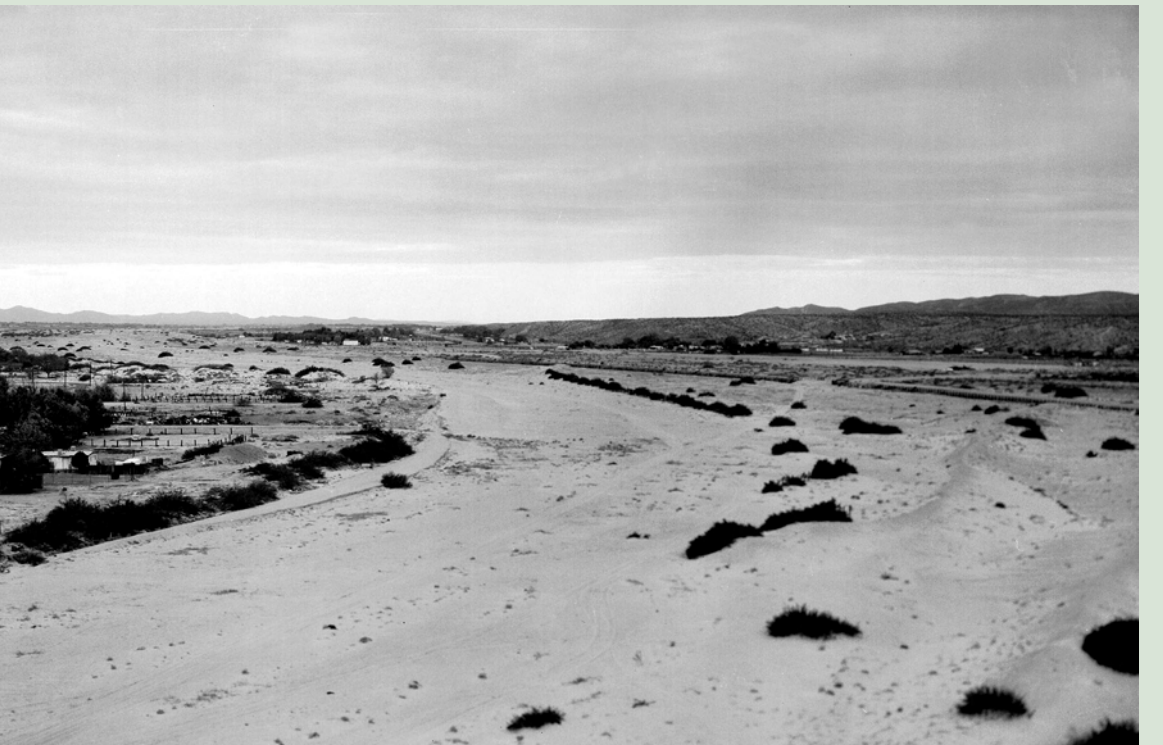
(1917). Thompson took this upstream view of the Mojave River from a small hill on its north bank at the main road crossing at Barstow. Current deflectors appear at right center, designed to minimize erosion of the north bank and its roads. The low vegetation at left appears to be mesquite on sandy hummocks, and scattered shrubs of unknown species appear throughout the open, sandy channel. What appear to be cottonwoods trees are visible in the distance (David Thompson 234, USGS Photo Library).

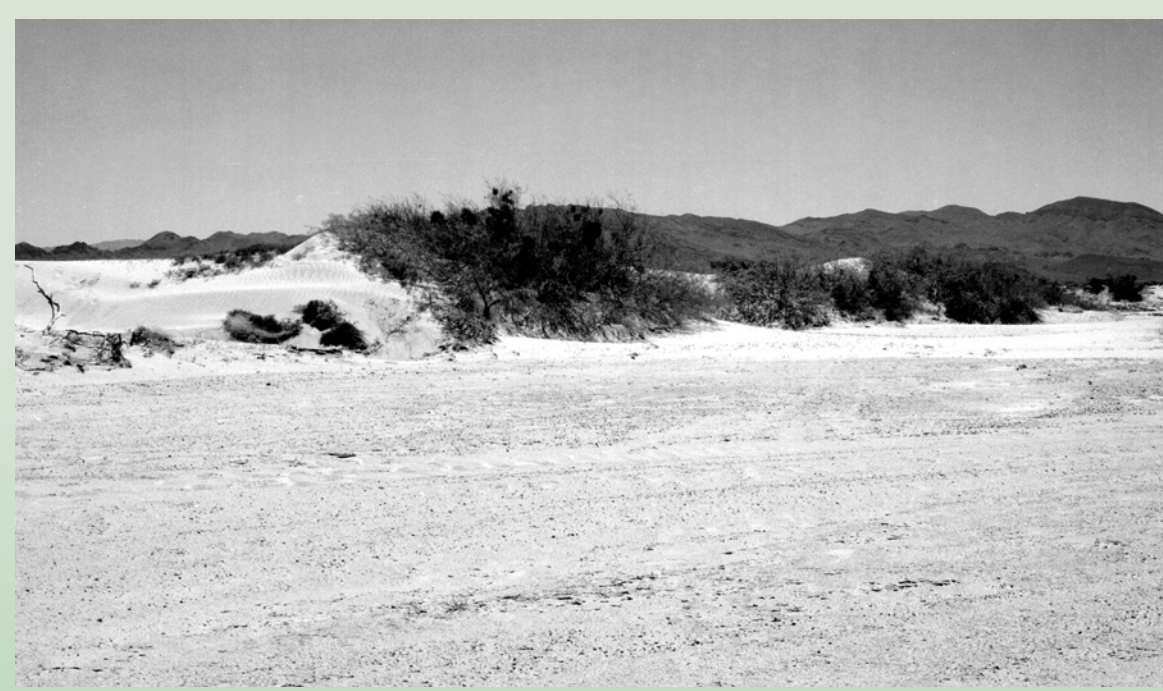
(April 25, 2001). During the last 138 years, hummocks with tamarisk, mesquite, desert willow (*Chilopsis linearis*), and California scale broom (*Lepidospartum squamatum*) have replaced the willows. Although this photo is of mesquite-covered dunes with a few thorn bushes, tamarisk is the dominant woody shrub along this stretch of the Mojave River bed (Dominic Oldershaw, Stake 4085).

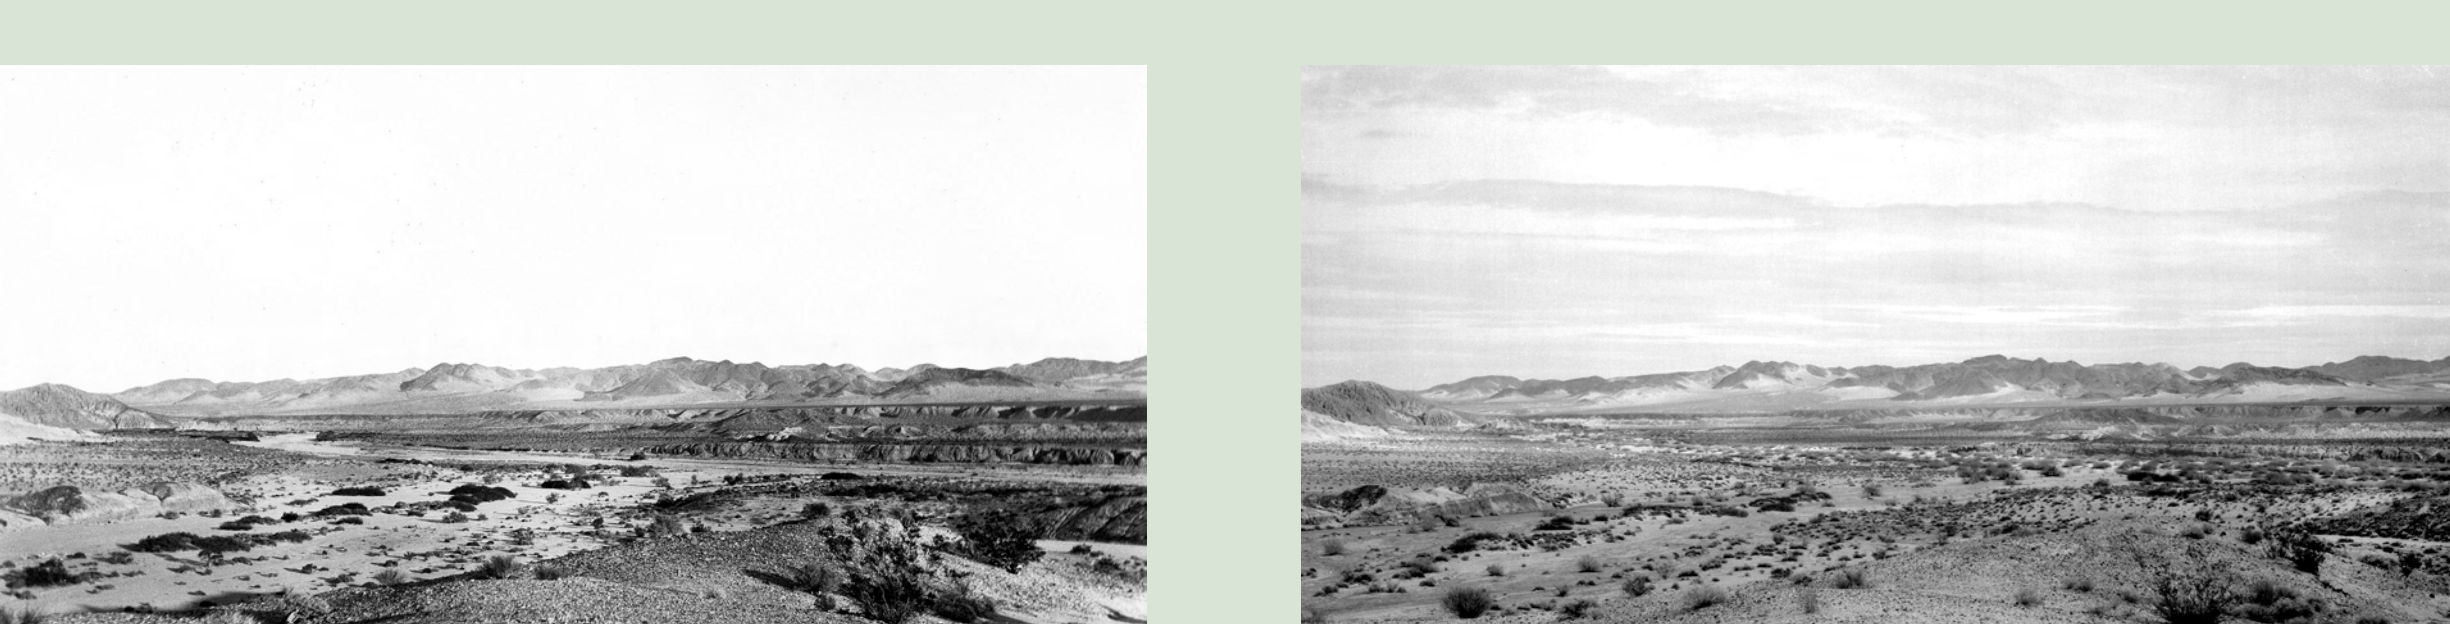
(1919). Manix Wash flows south into the Mojave River near the northern edge of the Cady Mountains. This view shows Manix Wash in the foreground and its confluence with the Mojave River (midground). Mesquite covers the dune hummocks in the wash. The Mojave River bed appears almost devoid of trees and shrubs in this view. Thompson also took photos a few hundred yards upstream (to the right). The upstream photos show patches of scattered trees, probably Goodding willows and cottonwoods (David Thompson 322, USGS Photo Library).

(March 2, 2001). The Manix Wash now has more shrubs, including many of the same mesquite hummocks present in 1919. Many of the other large shrubs and trees in the wash, tamarisk and desert willow, were uncommon in the early photo or not evident. No mesquite occurs beyond the confluence of the wash and Mojave River bed (midground). The Mojave River bed is now densely populated by tamarisks growing on hummocks of sand to the exclusion of all other species of shrubs and trees. Small remnants of native vegetation, including mesquite, can be seen on a few dunes at the north edges of the river bed (Dominic Oldershaw, Stake 116a).

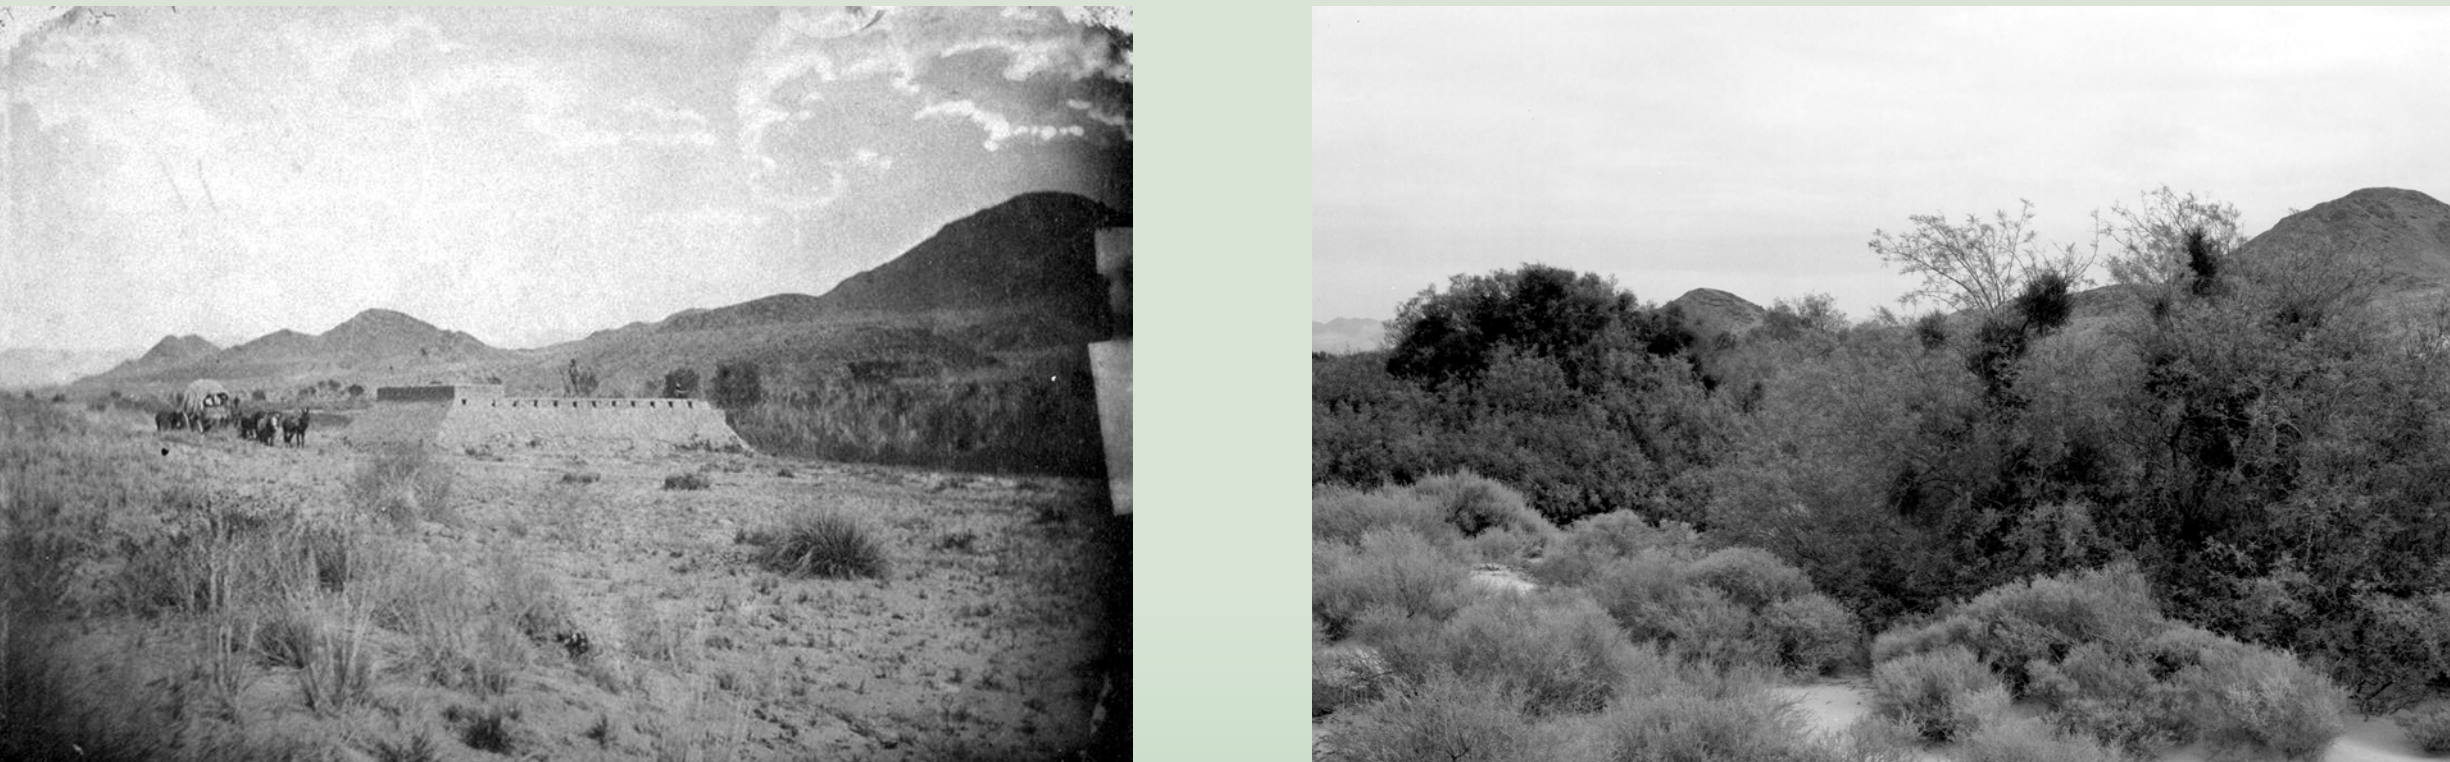
(1863). In the early 1860s, the U.S. Cavalry established several outposts at perennial water in the Mojave Desert for the protection of travellers along the Mojave Road, then known as the Government Road. The structure shown in this view is Camp Cady, on the north bank of the Mojave River northwest of the Cady Mountains. Behind and to the right of the fortification are riparian trees, which appear to be mesquite (plants just behind the fort), Goodding willows (both sides of fort), and coyote willow (right) (Richard D'Heureuse 1905-16894NA, courtesy of the Bancroft Library).

(October 23, 2000). Mesquite now blocks the view of the fort, which survives only in some broken foundations and a small commemorative sign. Mistletoe appears in some of these mesquite trees, which were very healthy at the time of this photograph. The foreground shrubs are cattle spinach. Cottonwood trees rise above some of the mesquite trees (Dominic Oldershaw, Stake 2107).

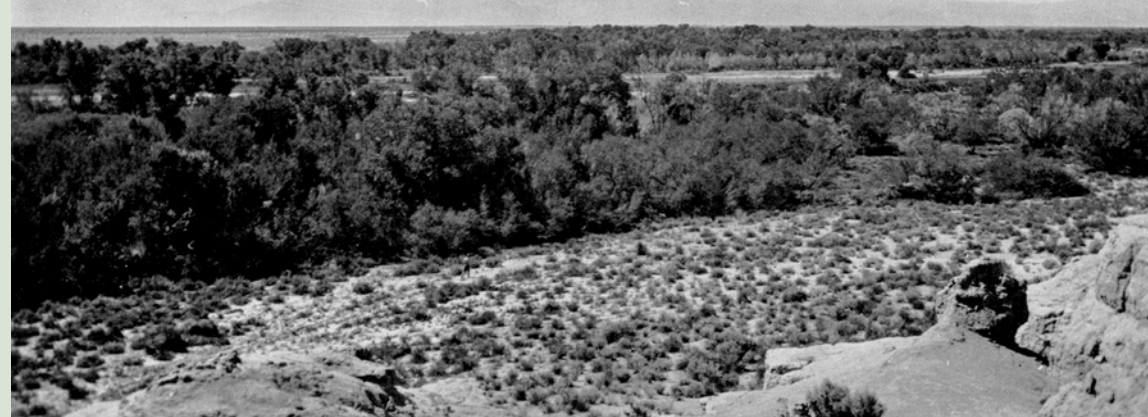
(1917). Downstream of Barstow, the Mojave River crosses a wide, sandy valley that, in 1917, had sand dunes and mesquite hummocks. Where the river approaches the northwest side of the Cady Mountains, its course apparently crosses a subsurface geological structure (either fault or geologic strata) that forces ground-water towards the surface. A zone of riparian vegetation consisting of mesquite, cottonwood, and Goodding willow was well established here in 1917. The channel of the Mojave River, which flows right to left across the center of this view, is relatively wide (David Thompson 15, USGS Photo Library).

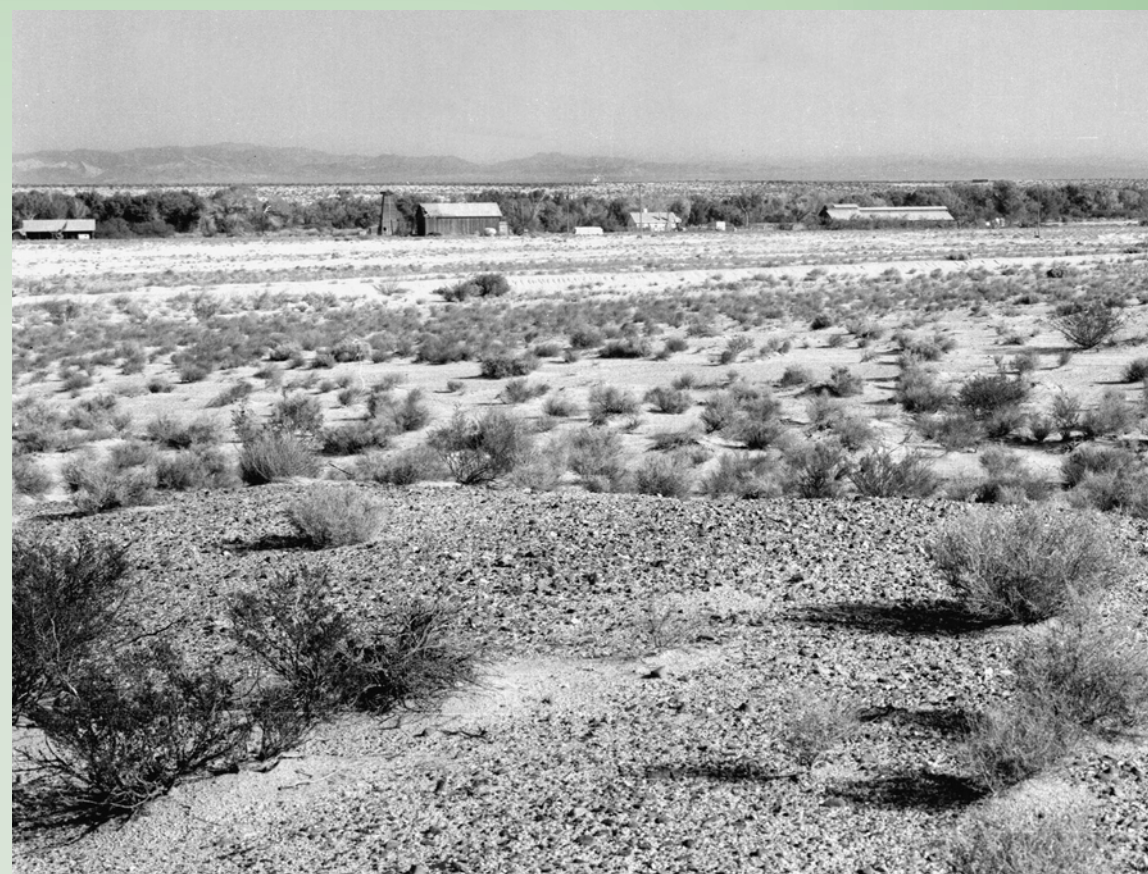
(October 25, 2000). Much of the midground vegetation was cleared for agriculture during private operation of Camp Cady Ranch. The ranch buildings and surrounding lands are now owned by the California Fish and Game Department, which ceased grazing and agriculture on the property shortly before this photograph was taken. The stature of the riparian community has increased as the cottonwoods have grown higher above the willows. Upstream and downstream from this reach, riparian vegetation is dying owing to ground-water pumping (Dominic Oldershaw, Stake 2115c).

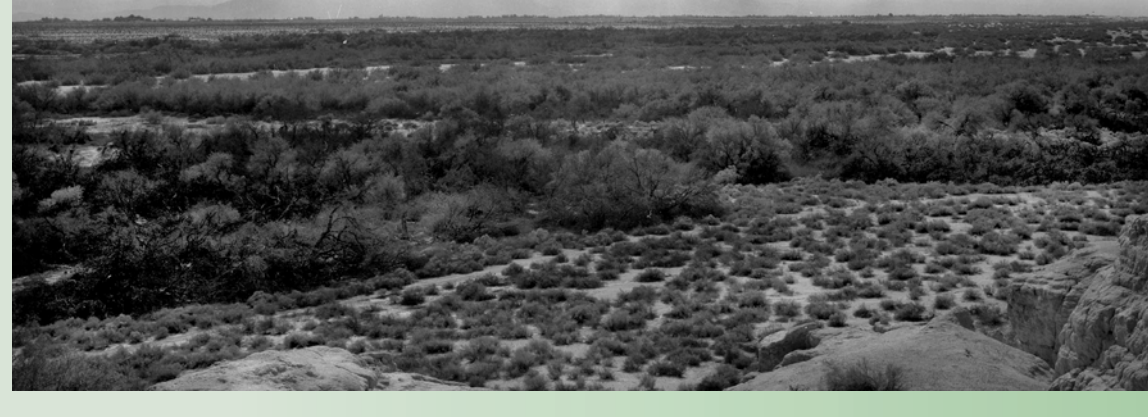
(October 25, 2000). This view across the upstream part of the Camp Cady Ranch shows a section where mortality of mesquite has been high owing to upstream ground-water pumping, much of it immediately upstream from the reach in this view, and tamarisk has increased considerably in the midground. At the time of this photograph, tamarisk removal was occurring in this reach. Despite the mortality, riparian vegetation increased during the middle of the 20th century before the dieback because the channel of the Mojave River is much narrower (Dominic Oldershaw, Stake 2117).
