CHANGES IN RIPARIAN VEGETATION IN THE SOUTHWESTERN UNITED STATES: Historical Changes Along the Mojave River, California

USGS GROUND WATER RESOURCES PROGRAM

U.S. GEOLOGICAL SURVEY OPEN-FILE REPORT OF 01-245, 2001

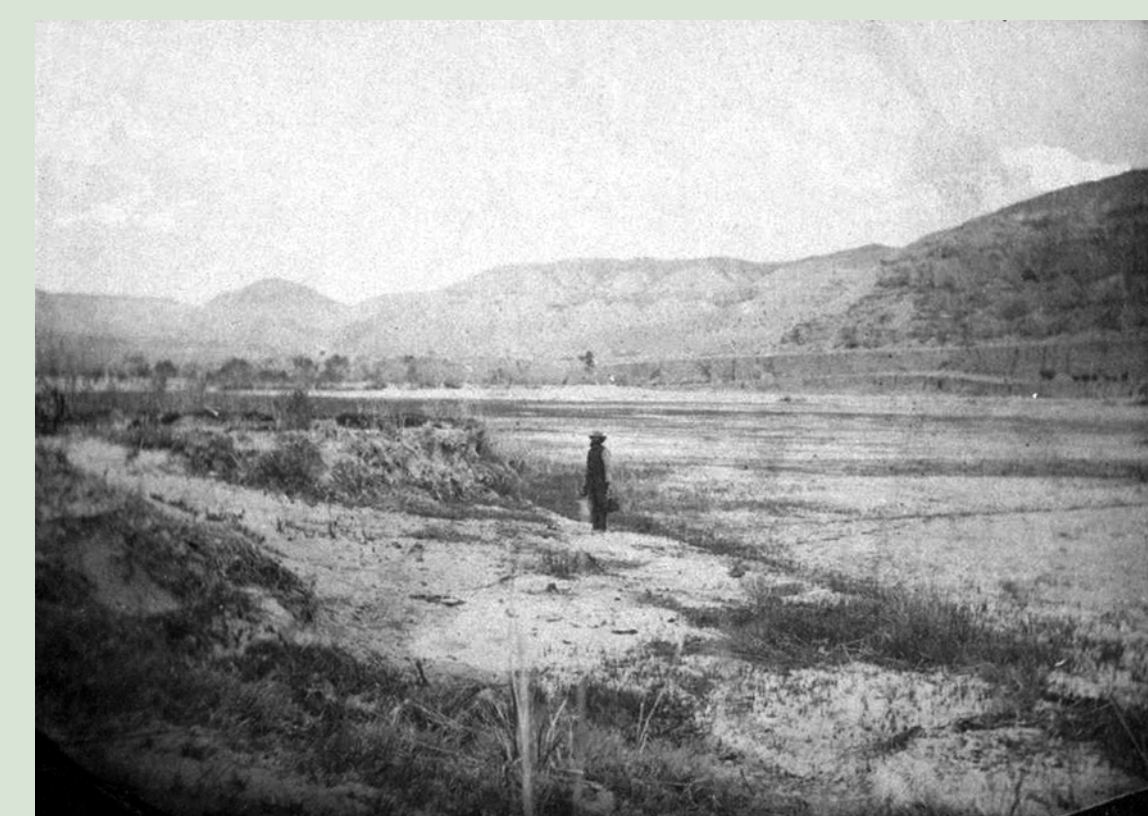
(October 25, 2000). Many changes have occurred in the last 137 years in Afton Canyon, spurred by large floods, cattle grazing, and manipulations of the riparian ecosystem. Changes to the riparian plants include the establishment of non-native tamarisk in the middle part of the 20th century, herbicide treatments to remove the tamarisk in the 1950s, and mechanical removal of tamarisk that began in the 1990s before this photograph was taken. Despite all these changes, riparian vegetation has obviously increased. The plants in the foreground are arrowweed (*Tessaria sericea*), with a small Goodding willow in the center. Mesquite are also present in the middle distance. At this site, the channel of the Mojave River contains perennial water with reeds and cattails but no open channel (Dominic Oldershaw, Stake 2116).

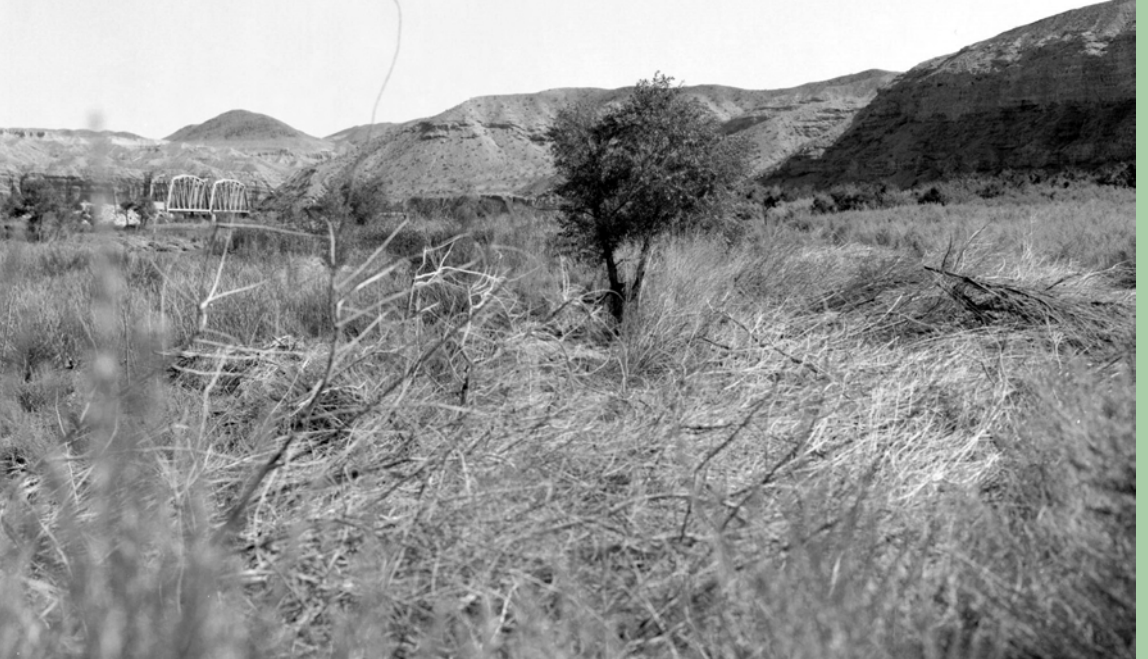
(March 1863). This downstream view of the Mojave River was taken at the head of Afton Canyon about a year after the 1862 flood. A wide, scoured channel with little riparian vegetation is present in the foreground, and larger trees of unknown species are in the middle distance. From this distance, it is impossible to determine whether these trees were cottonwoods or Goodding willows (Richard D'Heureuse 1905.16894NA, courtesy of the Bancroft Library).

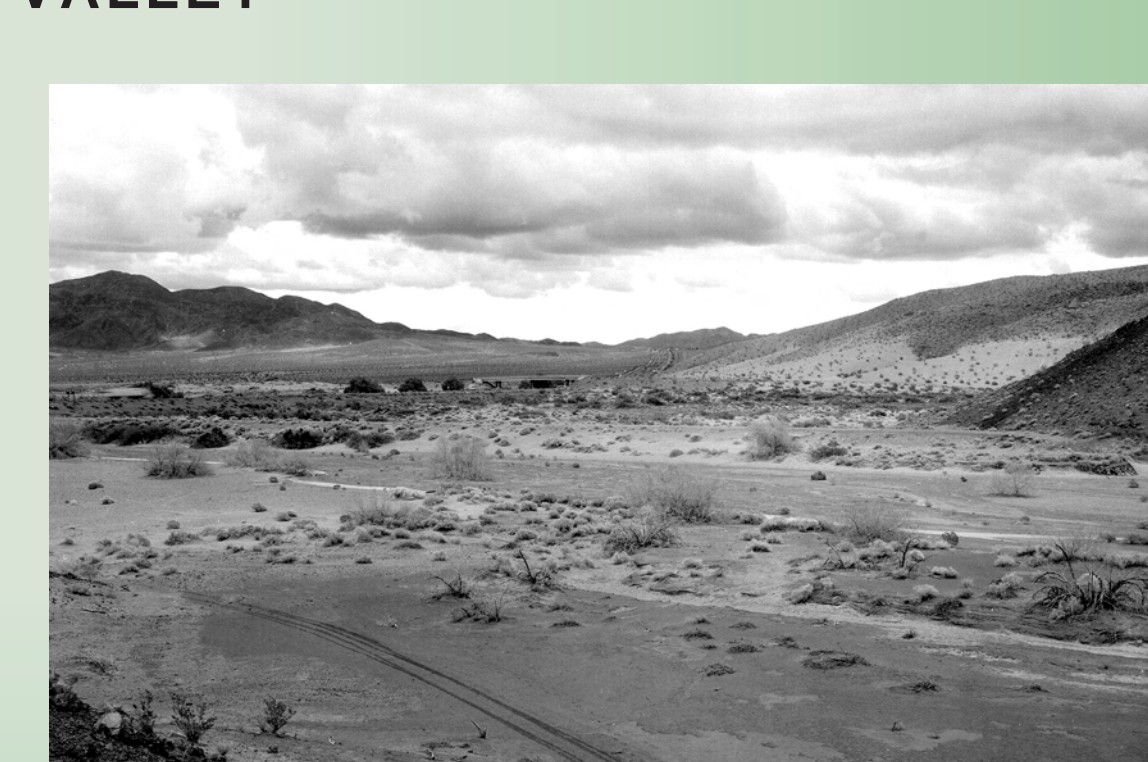
(February 26, 2001). In the intervening years, the dam in the foreground was breached, leaving a partial dike in the background. The large shrubs in the wash are desert willows, still alive but smaller and less robust than 82 years earlier. They are mixed with cattle spinach. In the background, the mesquites are gradually dying and being replaced by creosote bushes. One tamarisk is in the wash and several other tamarisks are along Interstate 15 (Dominic Oldershaw, Stake 105).
